OHIO RIVER BASIN
BROAD FORD RUN
GARRETT COUNTY,

NDI I.D. NO. MD 36

2 (BROADFORD RUN DAM)

PHASE I INSPECTION REPORT

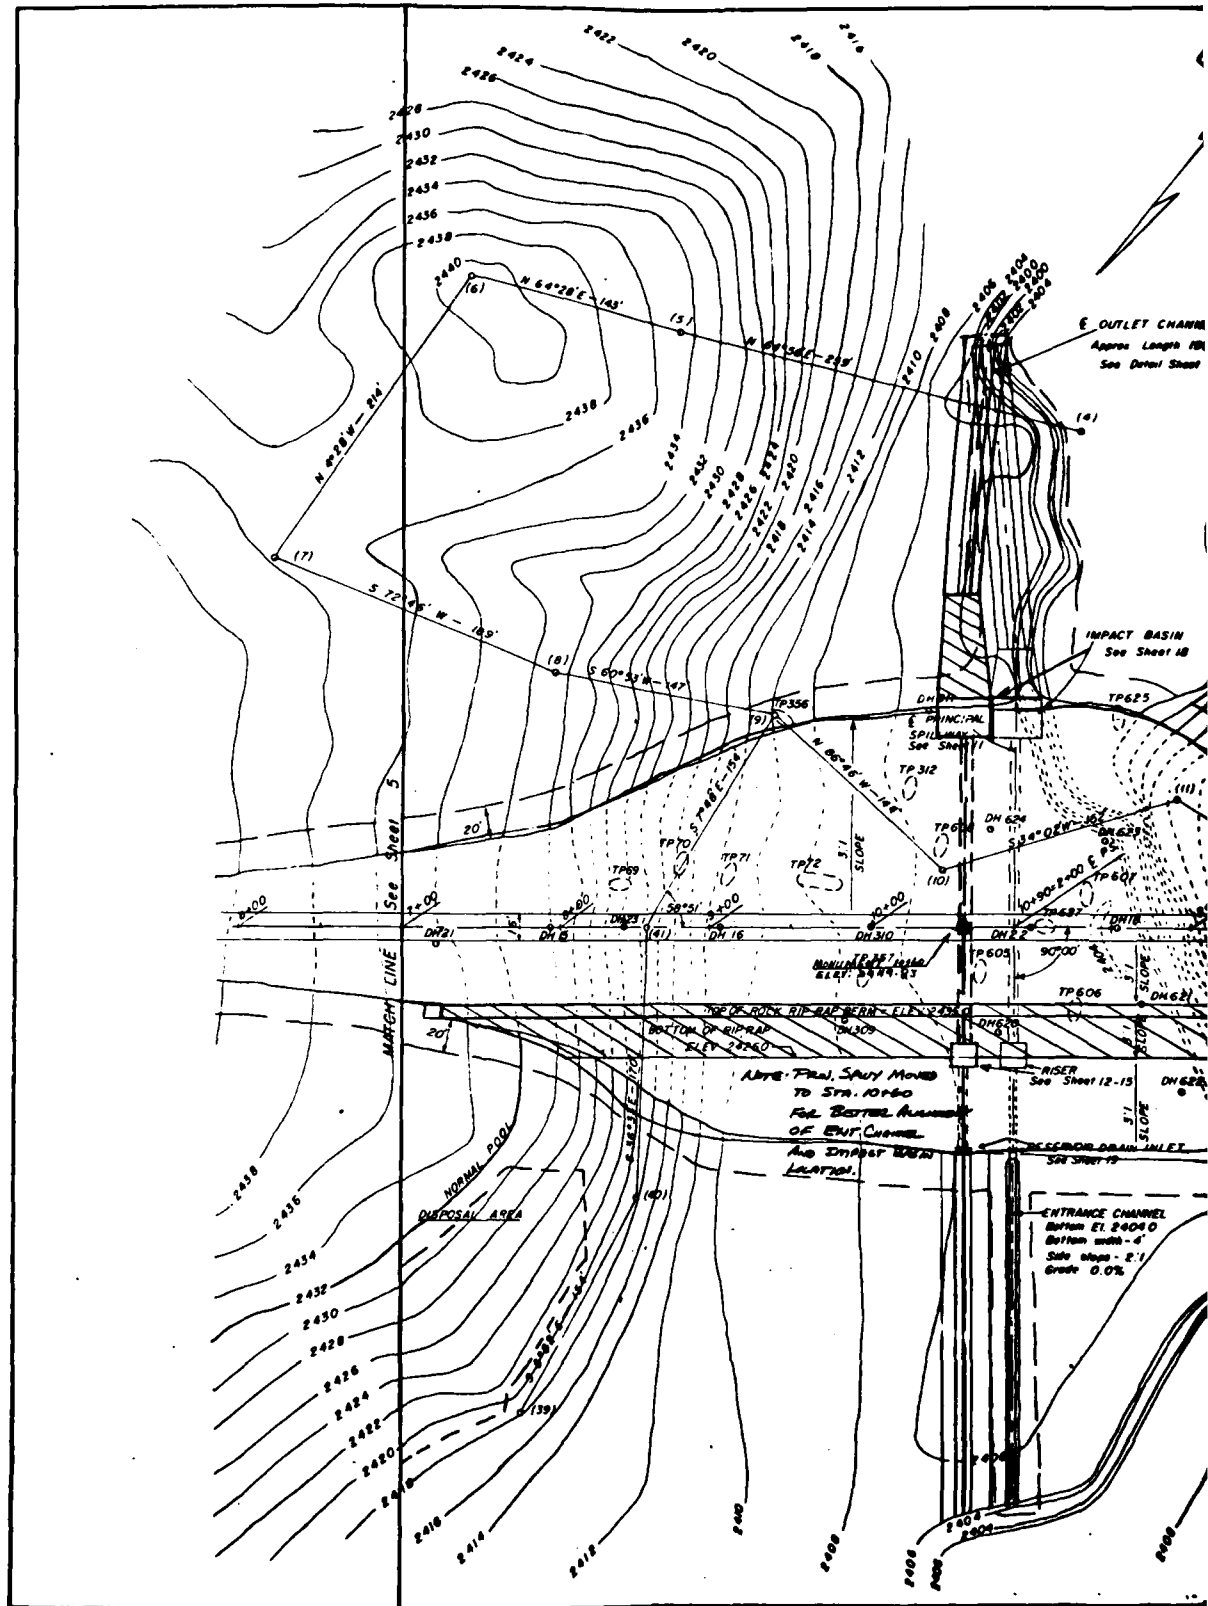
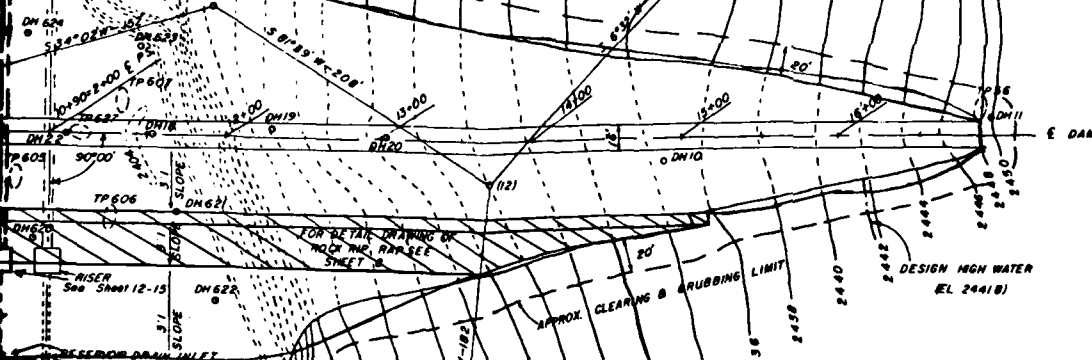
PLATE NO. 1

Ground water conditions at the dam site are complex. The general dip of the bedrock from west to east in conjunction with faulting, has resulted in artesian pressure. Artesian pressures of one (1) ft. up to five (5) ft. above ground level were encountered. (Drill holes: DH 620, DH 18, and DH 311; see Plate No. 1 for location.)

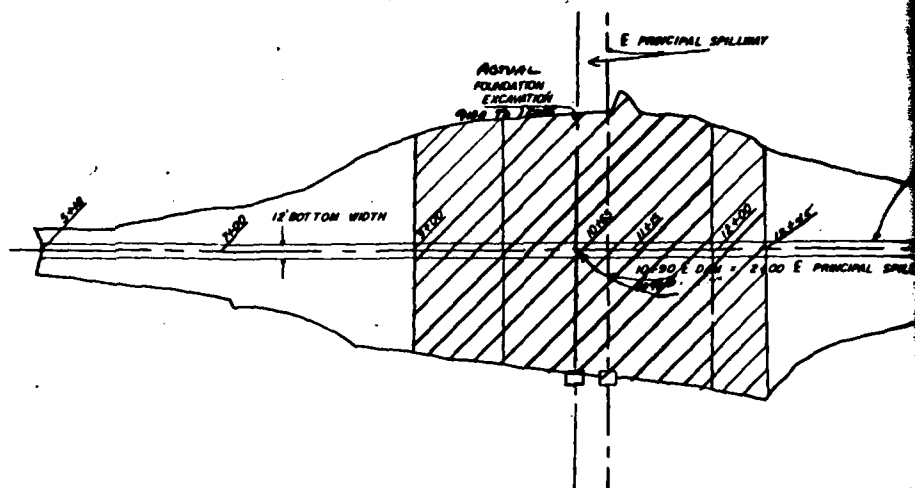
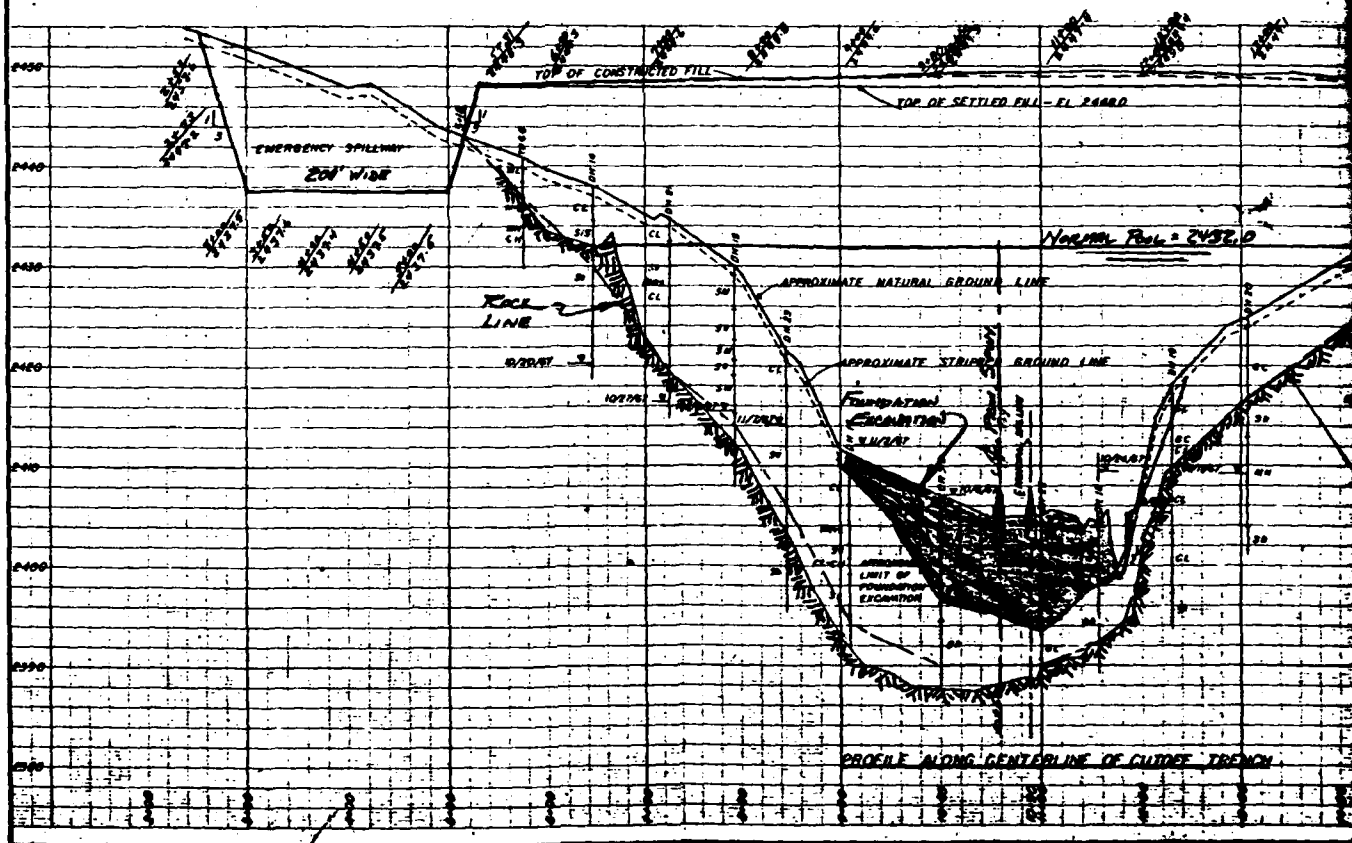
PLATE NO. 2

A cutoff trench is located at the centerline of the dam embankment. The cutoff trench extends along the dam foundation and abutments up to about 18 ft. below the crest of the dam. (Refer to Plate No. 2.)
